FRESH-MARKET QUALITY TREE FRUIT HARVESTER

PART I: SWEET CHERRY

ABSTRACT. A two-unit mechanical harvester was developed to harvest fresh-market quality sweet cherries (*Prunus avium* L.). Units were essentially mirror images. On each unit the harvester operator used joysticks to position and engage a rapid displacement actuator (RDA) on main scaffolds to effect fruit removal. Catching conveyors were designed to intercept falling fruit without damage and elevate the fruit to a collecting conveyor. Cushioned catcher pans on each unit were used to seal around the trunk and connect the two units. Main scaffolds were inclined to reduce damage as cherries fell to the catching surface. Ethrel (2-chloroethyl phosphonic acid) was used to reduce the fruit retention force of mature cherries to enable removal without stems or damage. The experimental harvester demonstrated potential for harvesting stemless sweet cherries with fresh-market fruit quality comparable to commercial hand-picked cherries. The catching/collecting system was effective with low damage inflicted to the cherries. About 90% of the cherries were removed from the tree and of those removed, 88% were collected and containeriz

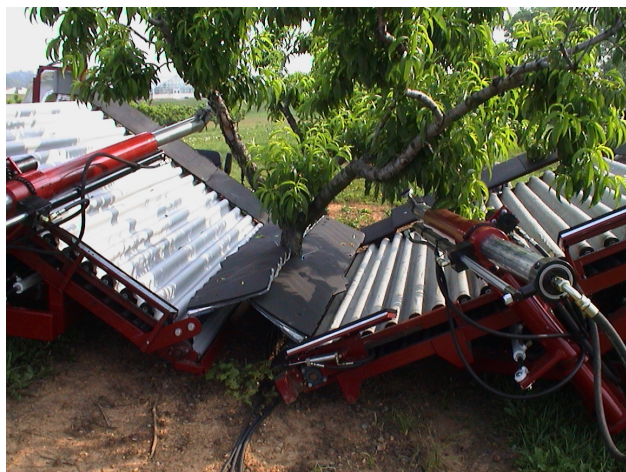
Figure 1. Front view of experimental sweet cherry harvester.

The harvester consisted of two separate units on opposite sides of the tree row (figs. 1, 2, and 3), which were essentially mirror images. Each unit was three-wheeled (front wheel steerable), all-wheel-hydraulic-drive with a driver,

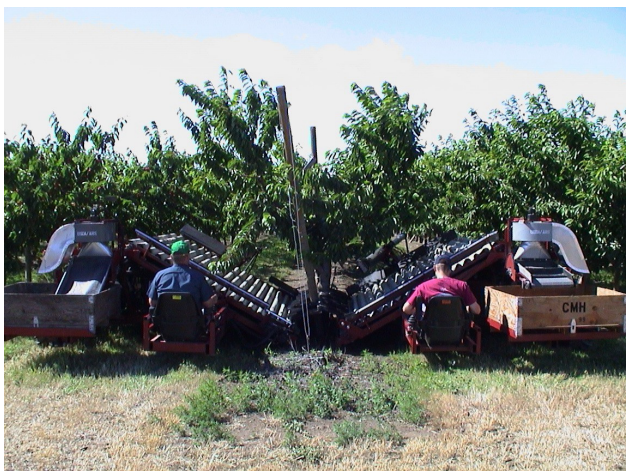
Figure 2. Rear view of experimental sweet cherry harvester.
